## NEW STYLE MICRO-DEOX/2000 WET SIDE

### NEW STYLE CASTING DIMENSIONS

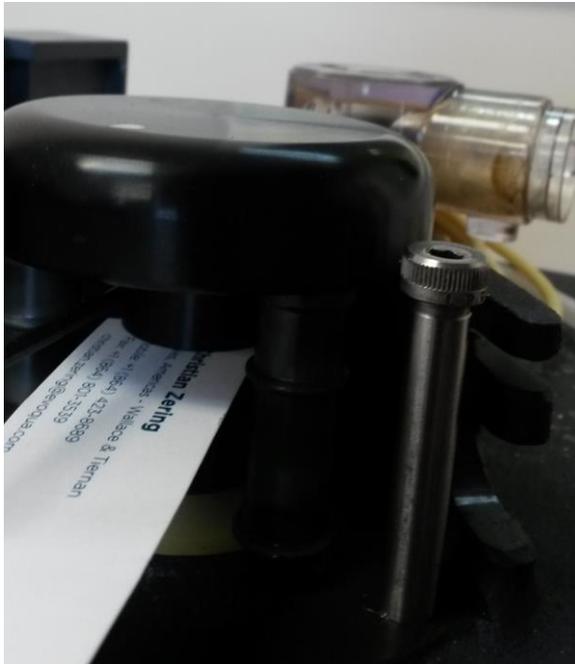
- Gap all rotors to 0.010" when installing. A business card works well as a spacer if a feeler gauge is not available. Insert the gapping device between the rotor and the casting (see photo below) and tighten set screw being sure the set screw is on the flat surface milled into the end of the motor shaft.

- For BX and earlier serial number units, install the shoulder bolt in the top position first and tighten all the way. Install the original standard hex bolt in the lower position. Tighten lower bolt to finger tight until the occlusion ring is flat against the machined casting surface, then ¼ turn to final position. DO NOT overtighten lower bolt.
- Be sure rotor pins, rollers and thrust washer are free of scaring and clean of dirt and debris before reassembly. Apply a thin coat of silicone grease to rotor pins only when installing the rotor and rollers. Do not use Molykote or graphite based lubricants or any other type of grease.
